FLORIDA
AMBIENT

EcoSummary

Whiting Field Branch East of State
Road 87 above Clear Creek
February 25, 2003

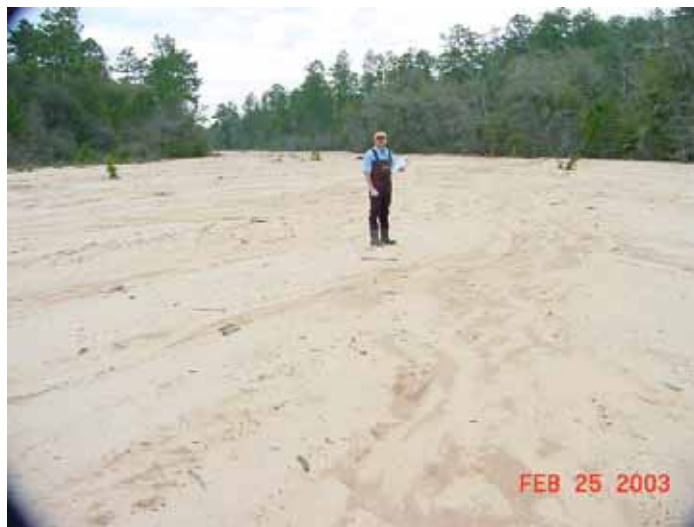
This biological assessment was conducted as an ecosystem partnership with the United States Fish and Wildlife Service (USFWS) for an Ecosystem Restoration Project in "Whiting Field Branch". Sand mining, historical logging activities and runoff directed from Whiting Field runways had caused sediments to completely fill Whiting Field Branch's stream channel and its riparian wetlands. The channel

filling sediments originated from this hillside runoff eroding a mile-long gully as large as 300 feet wide and 30 feet deep. The USFWS has initiated a restoration project in Whiting Field Branch that will include re-constructing a sinuous channel and re-planting wetland riparian vegetation. This BioRecon documents the pre-restoration benthic invertebrate community's condition in Whiting Field Branch. The BioRecon sample reach (Latitude 30 degrees 42 minutes 47.9 seconds North, Longitude 87 degrees 2 minutes 40.5 seconds West) is located just west of the Whiting Field boundary about 4 miles north of Milton. This Whiting Field Branch site (STORET # 33030147) is a second order stream draining southern pine plains and hills of subcoregion 65F. Whiting Field Branch is tributary to Clear Creek and flows into Pensacola Bay via the Blackwater River, Blackwater Bay, and East Bay. The Blackwater River segment below Clear Creek is 303d listed for Total Suspended Solids. The Blackwater River is designated as "Outstanding Florida Water" as is the Yellow River Aquatic Preserve in Blackwater Bay.

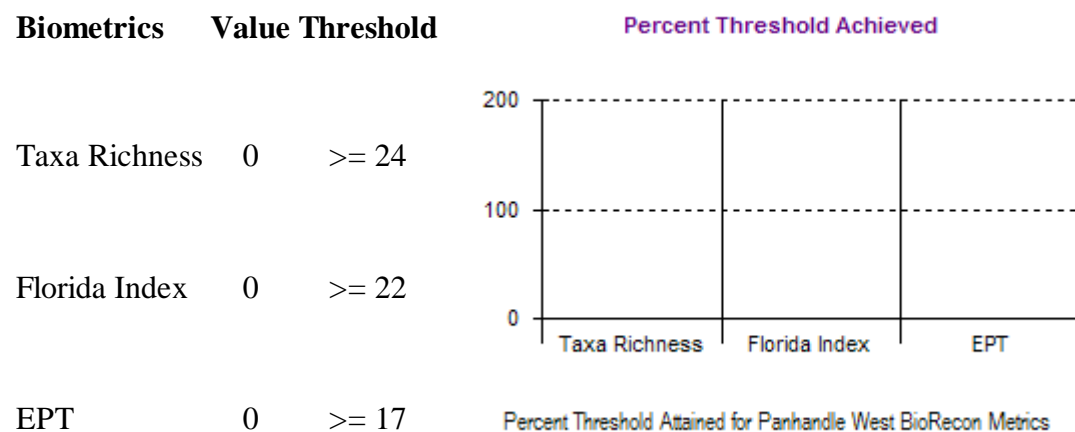
This Whiting Field Branch site totally failed all three biometrics to indicate a completely impaired condition.

The habitat assessment rated a lowest possible score (7%) caused by sedimentation completely burying the stream. During heavy rainfall high water velocity washes tons of sediments downstream. The aquatic biota was completely eliminated by excess sediment loading (100% habitat smothering). These sediments caused the surface water stream to flow under ground except during periods of significant rainfall. The watershed's entire riparian wetland forest was eliminated by sediment fill. The filled former stream riparian area had become an unauthorized dump (tires, trash, and household appliance observed), shooting range, and four-wheeler activity site. The landowner is working with the USFWS on these safety and health issues and to prevent this abusive land use. An Atlantic white cedar forest (listed as Type 97 by the Society of American Foresters) was the naturally dominant riparian zone.
