EcoSummary

Blackwater River below Kennedy

Bridge Road

May 26, 2005

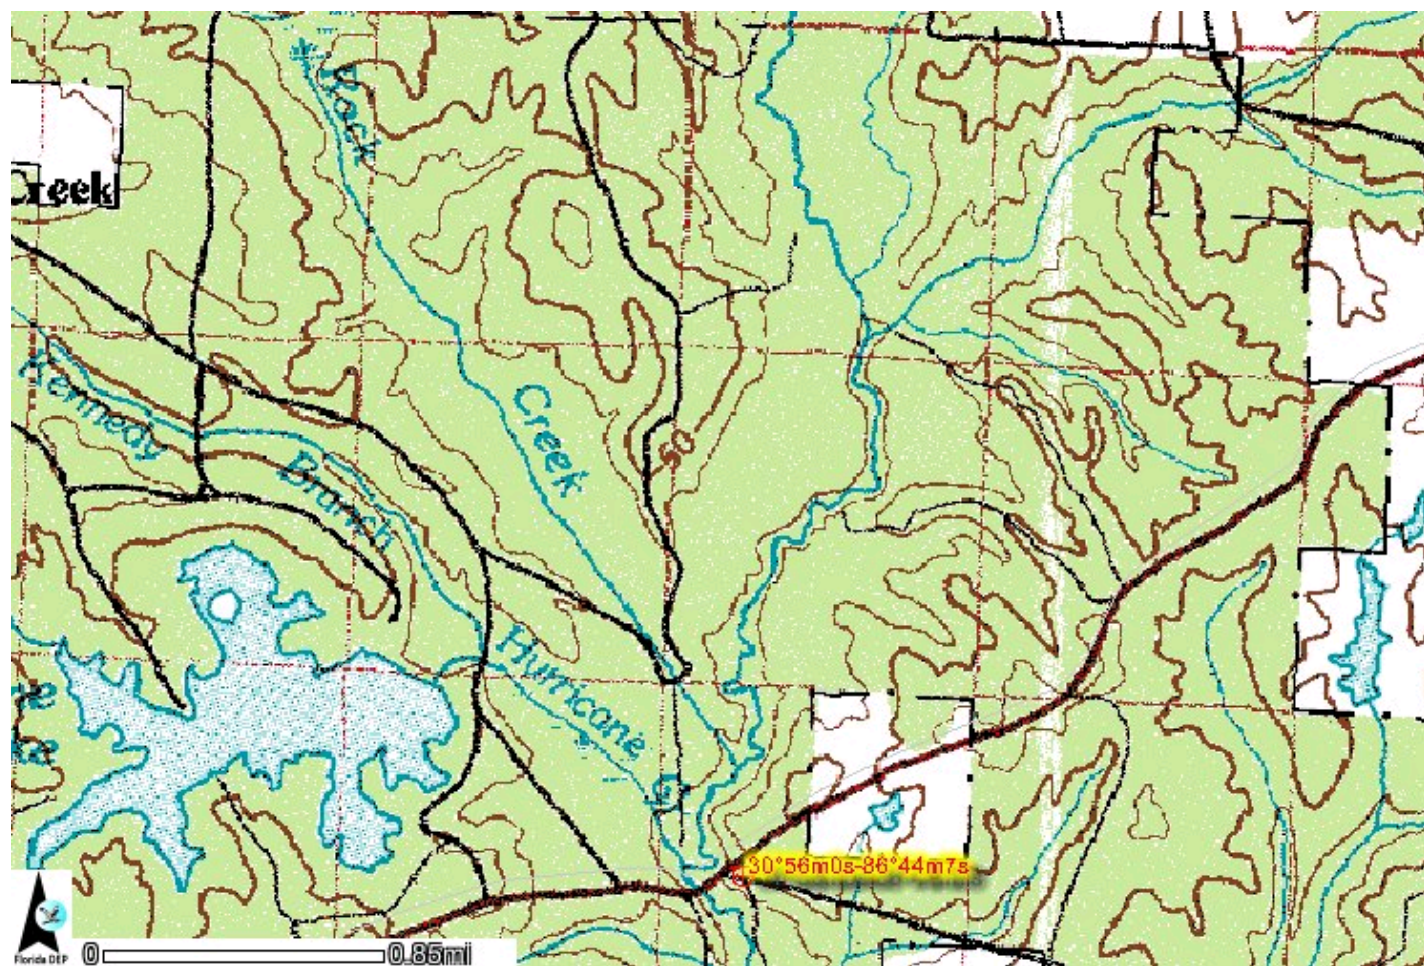
Blackwater River below Kennedy Bridge Road

The habitat assessment score rated 53% (marginal) because of poor conditions for Habitat Smothering, Substrate Diversity (from sediment impacts) and Right Bank parameters for Bank Stability, Riparian Buffer Zone Width, and Riparian Zone Vegetation Quality. The right bank was bare soil devoid of vegetation because of recreation access to the River (swimming area). Substrate Availability rated marginal with 14% productive habitat. Left Bank Stability rated suboptimal, having some small areas of erosion. Left Bank Riparian Buffer Zone Width and Riparian Zone Vegetation Quality also rated suboptimal. Water Velocity and Artificial Channelization rated in the optimal range.

The macroinvertebrate community in the Blackwater River below Kennedy Road was impacted by road sediment runoff compared to background conditions. Best Management Practices previously instituted by the BRSF had reduced sediment runoff. Kennedy Bridge had been elevated above the road approach levels and road swales and turnouts were maintained to limit sediment runoff to the River. Paving the Kennedy Bridge road approaches will reduce maintenance cost to keep the road open and prevent erosion after heavy rainfall. Restoration has good potential to restore fish and wildlife habitat on the left bank and enhance recreation on the right bank. Reducing the road sediment load will re-expose more productive fish and wildlife habitat and diminish unsightly silt and clay deposits on the white sand of the recreational area shoreline.
