# Ecological and Morphological Significance of Old Growth Deadhead Logs in the Blackwater River

Donald Ray

FDEP NWD Biologist

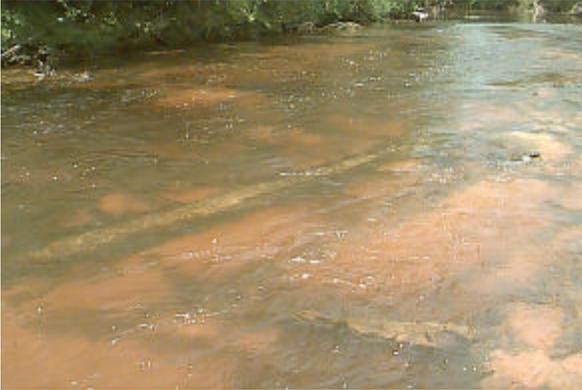
The pine log pictured above (19 feet length and 16 inches in diameter) provided fish and wildlife habitat in the river at the site above Highway 4. The Atlantic White Cedar log (25ft. by 16in.) in photograph #2 created a riffle in its mid-stream site. Both logs located in the middle of the channel created habitats in an otherwise relatively unproductive sand bottom. The #3 photograph showed aquatic mosses, liverworts and algae attached to the log. These plants provide additional food and habitat value of the log for fish and wildlife (#4).

#1 Blackwater River above Hwy 4, pine log habitat mid-stream.

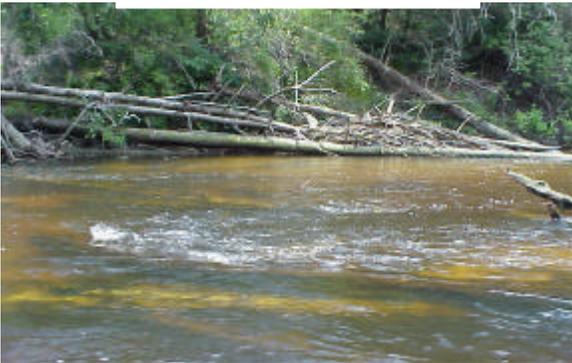
#2 Riffle created by cedar log.

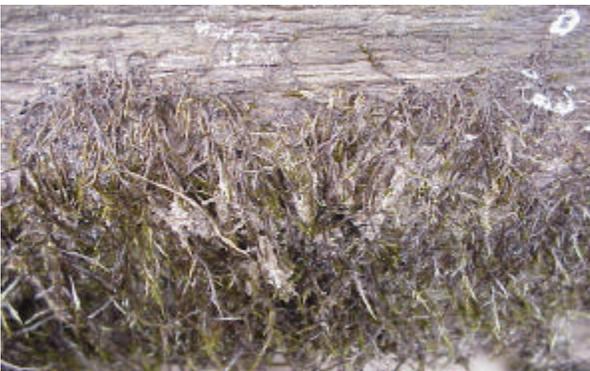
#3 Mosses, liverworts, and algae growth.

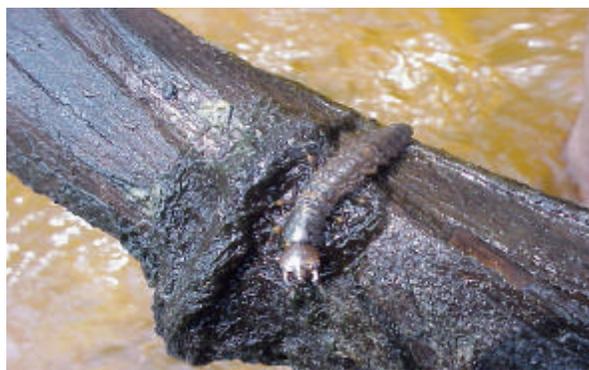
#4 Hellgrammite.

The habitat values were determined by dislodging the stream invertebrates from the two logs with a brush into a driftnet. Sampling results indicated highly productive and diverse aquatic macroinvertebrate communities from both logs. Cleanwater indicators (photograph #4) dominated the logs' healthy well-balanced aquatic communities. The biota of the logs surpassed the thresholds established for a 4 sweep BioRecon of multiple productive habitats (FDEP 1996b). The logs also had a more diverse and productive fauna than that found in a 20 sweep Stream Condition Index (FDEP 1996b) at a Blackwater River reference site at Highway 4. The biometric value comparisons of the logs, Blackwater reference site and western panhandle thresholds are as follows:

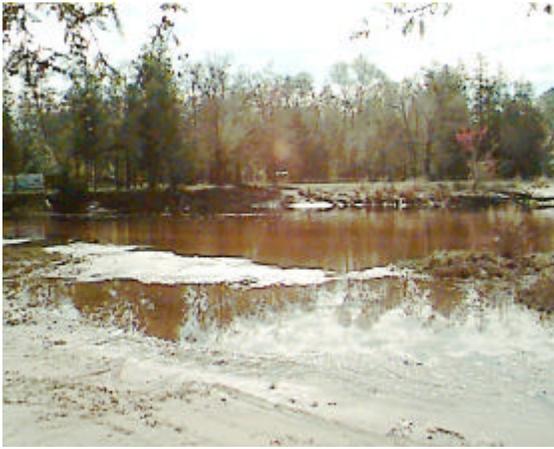
This area of the Blackwater River State Forest had quite a bit of second growth pine and cedar felled by recent hurricanes. Many of the trees in the river had been cut by canoe livery businesses as they leaned over the river channel (# 7). However, much of the downstream river channel with approximately only 1-% woody debris was shallower and wider (#5). The channel near the sample site with much higher % woody debris was narrower with more stable banks (#6).

#5 Blackwater River at Hwy 4 park < 1 meter depth, 70 meters wide, ~99% sand.

This adds the to habitat smothering (photographs #5& 10) that has already indicated by severe sedimentation problems (FDEP 1999d). Restoration of historic concentrations of woody debris at proper locations in the Blackwater River would enhance fish and wildlife populations. This restoration would also improve channel stability/stream morphology as observed at the sampled log sites (i.e. photograph # 6).

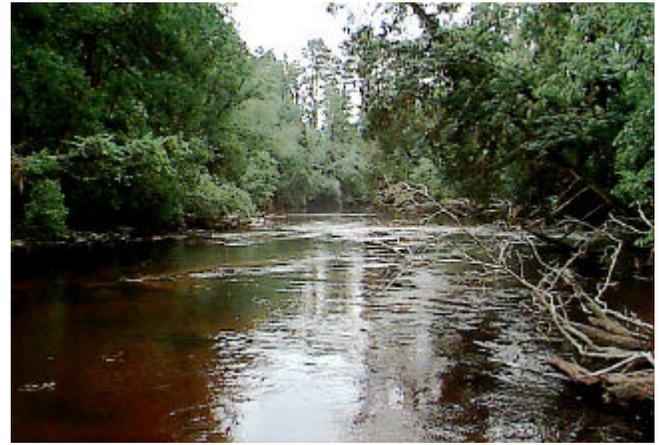
#6 Blackwater River log sample site 1 to >2 meters depth, 20-50 meters wide.

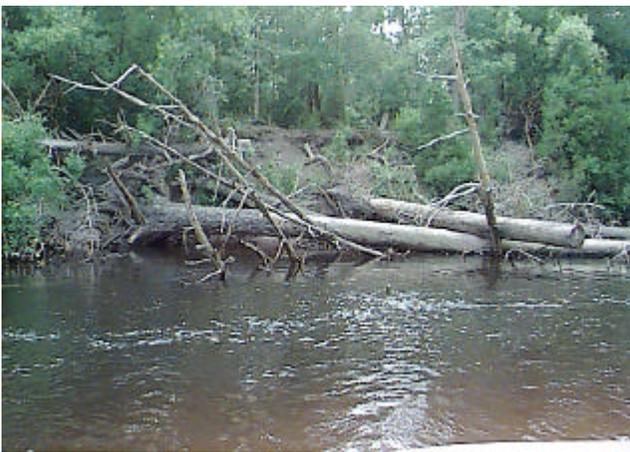
Fish (darters, shiners) were observed feeding on the logs. Fish eggs and other invertebrate were observed attached to the logs and the vegetation growing on the wood. Wallace and Benke 1984 found wood is important to fishes, providing a rich source of invertebrate food, habitat, and cover. Benke et al (1979) reported several species of game fish forage almost exclusively on invertebrates associated with these woody substrates. Wallace and Benke 1984 reported that snag or woody habitat was the major stable substrate in southeastern Coastal Plain sandy-bottom streams and a site of high invertebrate diversity and productivity. Wood was found to be a major structural feature (43%) in a study of middle-order streams (fourth to seventh) of the southeastern Coastal Plain (Wallace and Benke 1984). They stated the “quantification of wood habitat seems mandatory to assess past or potential impacts of snag removal on ecosystem processes in low-gradient streams”. To evaluate the impacts of log removal to the Blackwater River fishery, compare the 43% woody debris naturally present in coastal streams to the approximately 1% found in the lower River up to Highway 4. A Game and Fish Commission letter (1999) suggested no removal of deadhead logs from the Blackwater River upstream of the State Park at the Deaton Bridge. Rosgen (1993) presented a guideline to assist fisheries biologist to evaluate the suitability of fish habitat structures including logs for stream restoration. Severe erosion caused by increased runoff from landuse activities had created numerous bank failures (photograph #s 7&8).

#7 Recently cut fallen old growth pine and cedar.

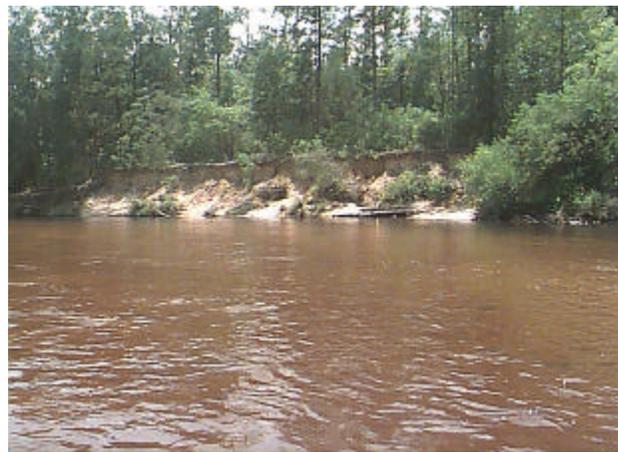
#8 Bank sloughing.

A more diverse and productive wildlife community was found on the old growth logs than bioassessments of 100 meter reaches of river at the Blackwater River reference site near the Highway 4 wayside park boat ramp. These findings are similar to the results of sampling deadhead logs on the Choctawhatchee River (FDEP 1999a), Chipola River (FDEP 1999b) and the Yellow River (FDEP 1999c). Removal of an unquantified amount of the few remaining logs would have a negative impact to the river's fish and wildlife community. Threatened fish species such as the Atlantic sturgeon utilize use the logs for food and the deep holes created by the logs for cover. Bank instability (photograph #8) accelerates when woody debris is removed from the stream channel.

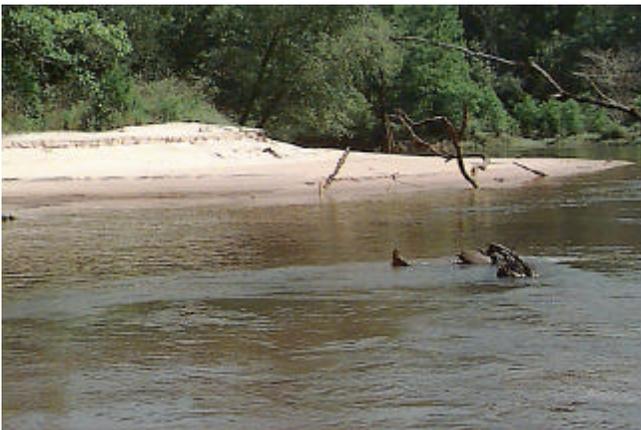
Sediments from the bank failures and upland sources had smothered much of the fish and wildlife habitat in the area below Highway 4. Habitat assessments in the lower Blackwater River during December 1998 found only approximately 1 % woody debris as available habitat (FDEP 1999d). Wallace and Benke (1984) found wood has a major influence on the hydrodynamic behavior of the river. Gordon et.al (1994) reported that larger woody debris may play an important part in channel stabilization and removal may have long-term effects on

# 9 New sediment.

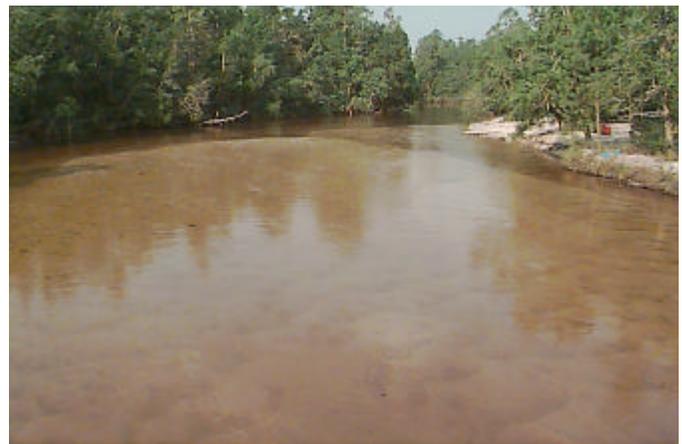
# 10 Channel smothering at State Park, woody debris absent.
